## **Breast High Road – report for the Lake District Green Lanes Alliance**

### **Lake District Green Lanes Alliance survey in August and September 2020 - summary**

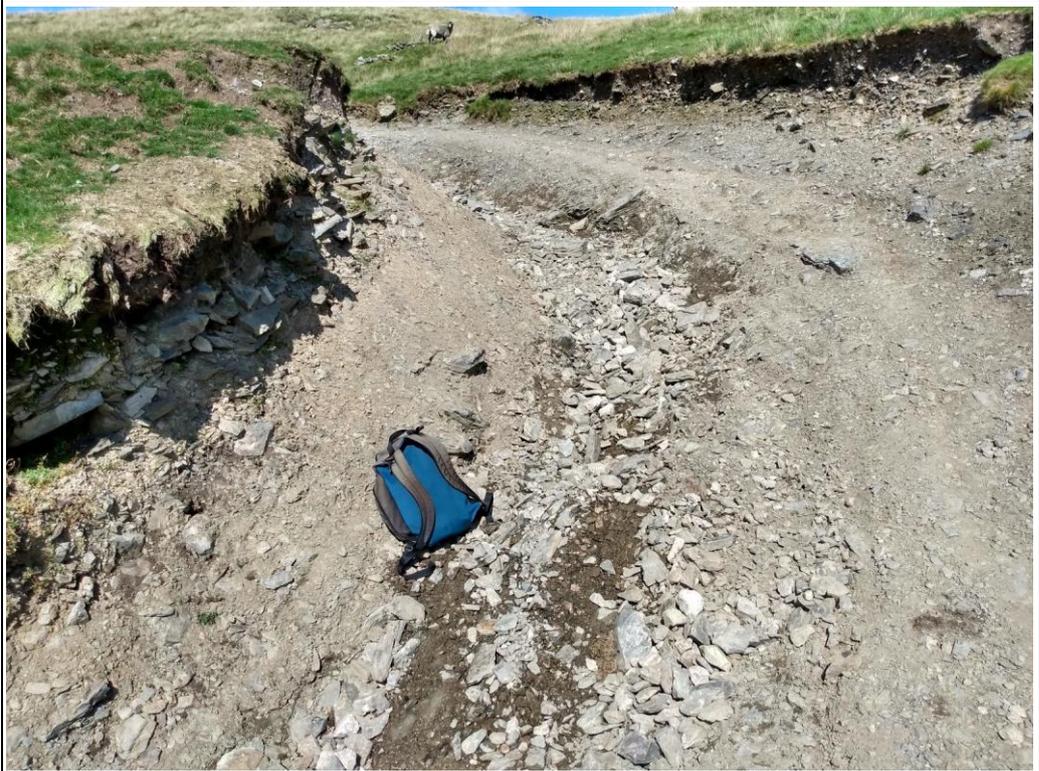
The route is in a trench almost 2 metres deep at this corner. There is a broken crossdrain a short distance above this corner.  
NY 562 040

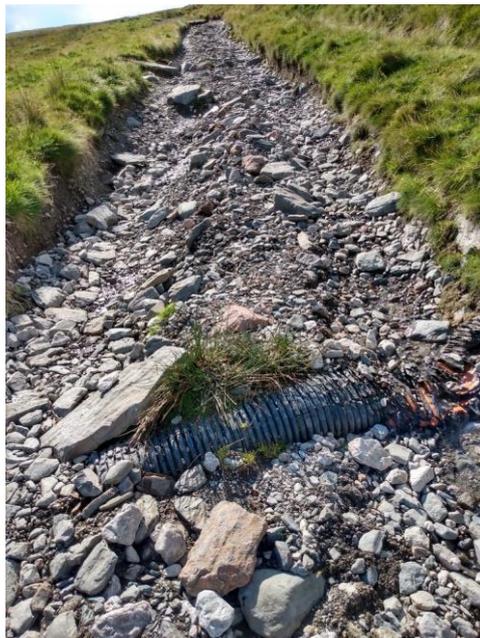
A transverse drain which took water from the drainage ditch on the right hand side of the route to a ditch on the left hand side. Now exposed, broken and bringing water onto the route.  
NY 567 045

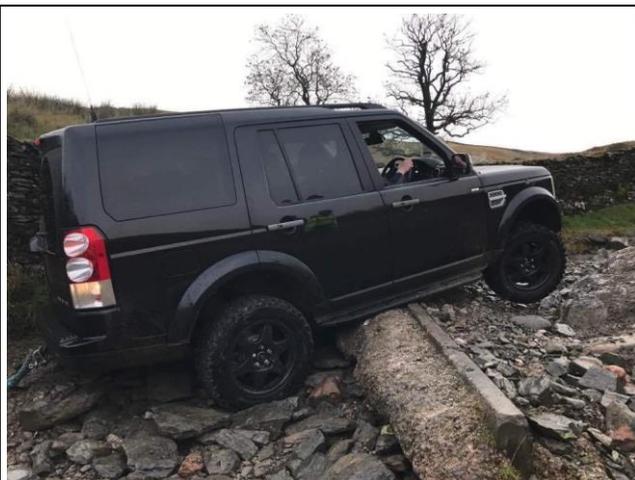
The concrete “steps” are concrete over transverse drains, presumably the drainage installed by Cumbria County Council in 2012. One of the photo below shows how the surface of the route had been eroded below a drain by 2017, making it difficult for a 4x4 to cross it.

4x4 struggling to cross transverse drain, March 2017. This is presumably the exposed pipe which the HOTR survey of 2016 noted was very difficult for 4x4s to traverse

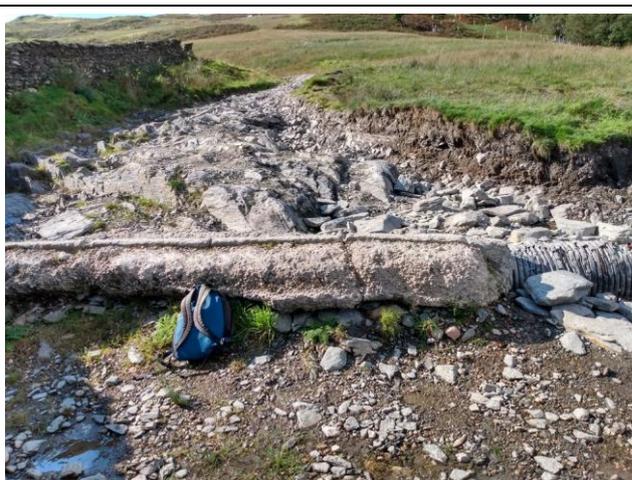
The concrete covering of the drain and the drain itself are broken and the route surface further eroded, September 2020. NY 569 046

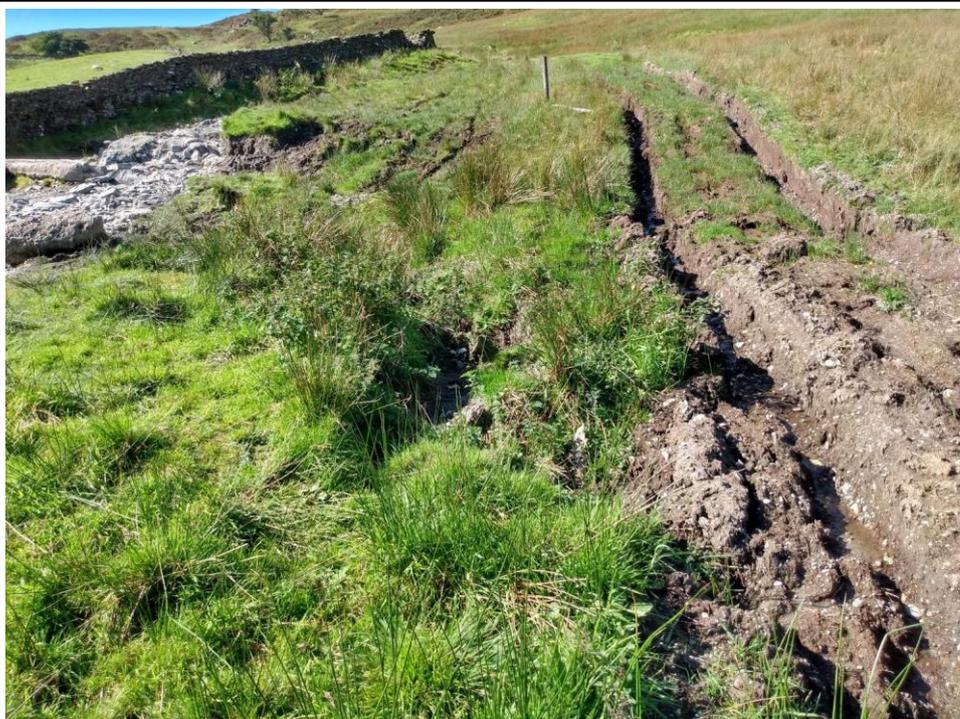
4x4s and motorbikes have made ruts in the pasture, as they leave the route to avoid the step caused by erosion around the transverse drain at NY 569 046

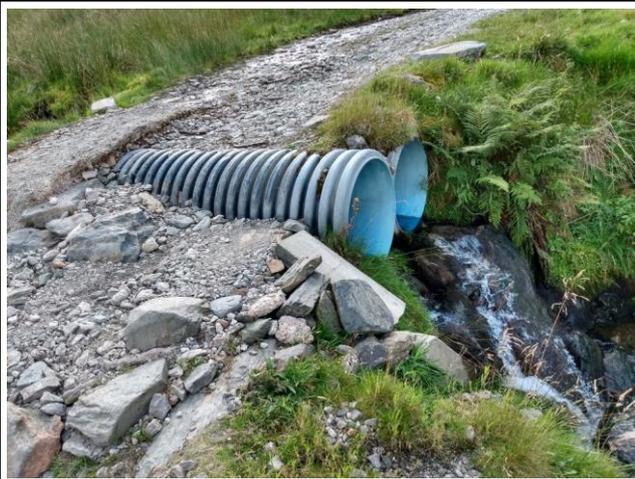
Concrete protection for piped stream crossing partially eroded away. NY 569 046

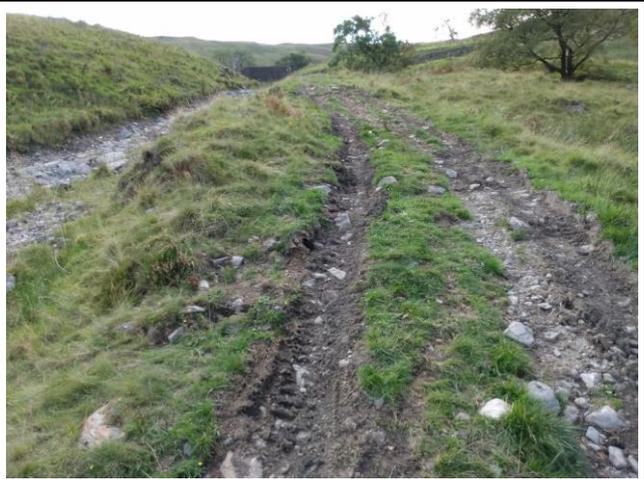
Tracks of motorbikers who have deviated from the stony route. NY 571 047
